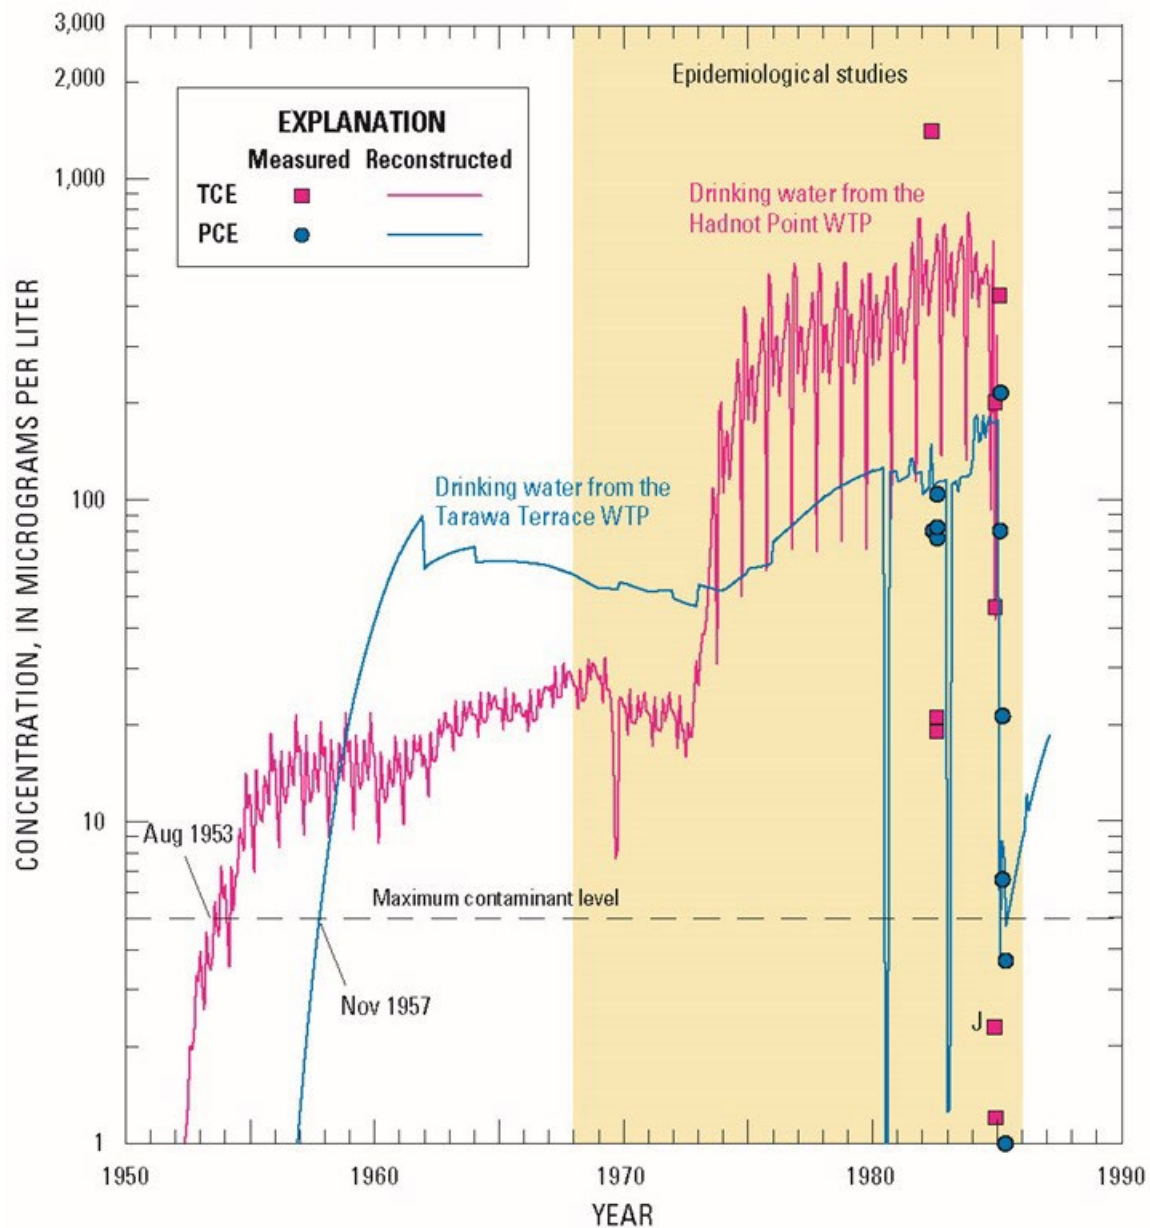
Figure 7.29. Reconstructed (simulated) and measured finished-water concentrations of tetrachloroethylene (PCE) and trichloroethylene (TCE) at the Tarawa Terrace and Hadnot Point water treatment plants (Maslia et al. 2016).
